Certificate of Testing Result

TEST REPORT

Measurement of Ozone (O₃) Leakage of Multi-Purpose Personal Home Sterilizer in Each Use

**Air Resources Research Center
Korea Institute of Science and Technology (KIST)**

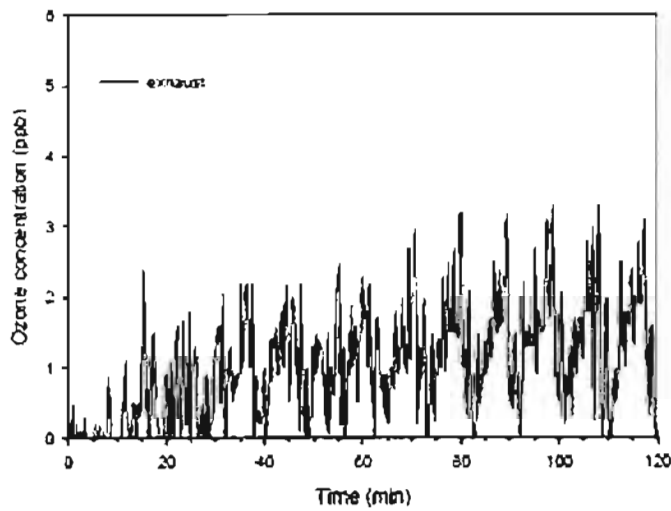
Picture 5. (Continued)

Picture 5(c) shows the change of ozone density of 1,350-time used MPPHS. Its state of ozone leakage is less distinct than zero-used (new) and 450-time used MPPHSs. Leakage density of ozone is also lower than 4 ppb. Picture 5(d) shows the change of ozone density coming from 2,000-time used MPPHS. The state of ozone leakage is similar to that of the 1,350-time used MPPHS and ozone density of leakage is also lower than 4 ppb.

There is a slight difference in the state of the ozone density leaked from the exhaust port according to the frequency of use among the 4 kinds of MPPHS. When an MPPHS is equipped with an ozone resolution catalyst only, ozone leakage is less than 10 ppb that is 1/5 of the regulation (50 ppb) of ozone leakage. When a MPPHS is equipped with an active carbon filter as well as an ozone resolution catalyst, the ozone leakage is less than 5 ppb that was 1/10 of the regulation (50 ppb) of ozone leakage.
